HOME CONDITION REPORT

19, Holland Street
BRIGHTON
BN2 9WB

Report reference number (RRN) **18402**
Inspection date **2 March 2007**

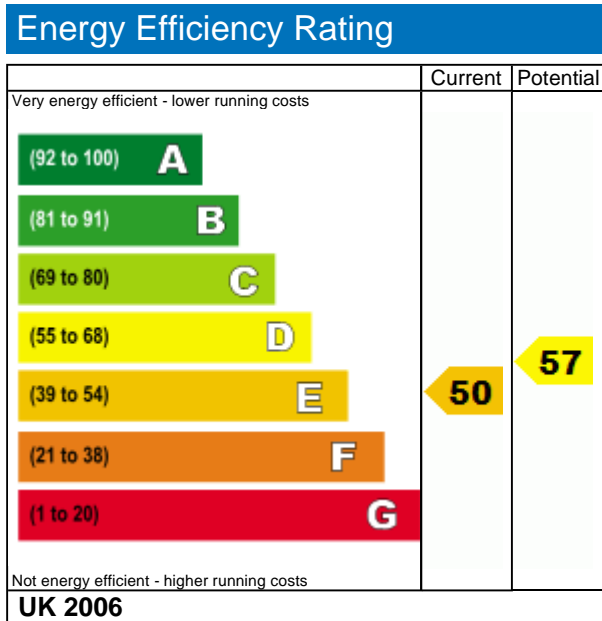
The energy efficiency rating is a measure of the overall efficiency of a home. The higher the rating, the more energy efficient the home is and the lower the fuel bills will be.

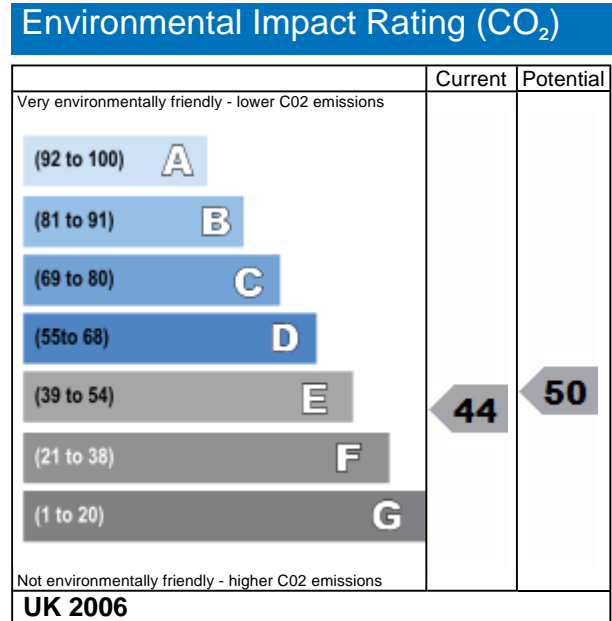
The environmental impact rating is a measure of a home's impact on the environment in terms of carbon dioxide (CO₂) emissions. The higher the rating, the less impact it has on the environment.
